ROTTED POSTS?

TWO PERMANENT SOLUTIONS FOR ROTTED WOOD POSTS

Perma-Column® solution

Sturdi-Wall® Plus solution

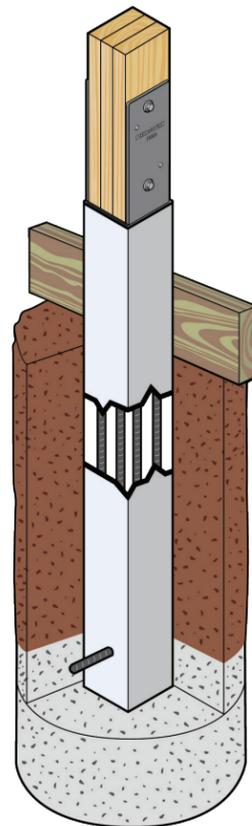
Available in 7 models

- PC4600 fits 4" x 6" solid post
- PC6300 fits 3-Ply 6" column*
- PC6400 fits 4-Ply 6" column*
- PC6600 fits 6" x 6" solid post
- PC8300 fits 3-Ply 8" column*
- PC8400 fits 4-Ply 8" column*
- PC8500 fits 5-Ply 8" column*

*Nail or glu lam column

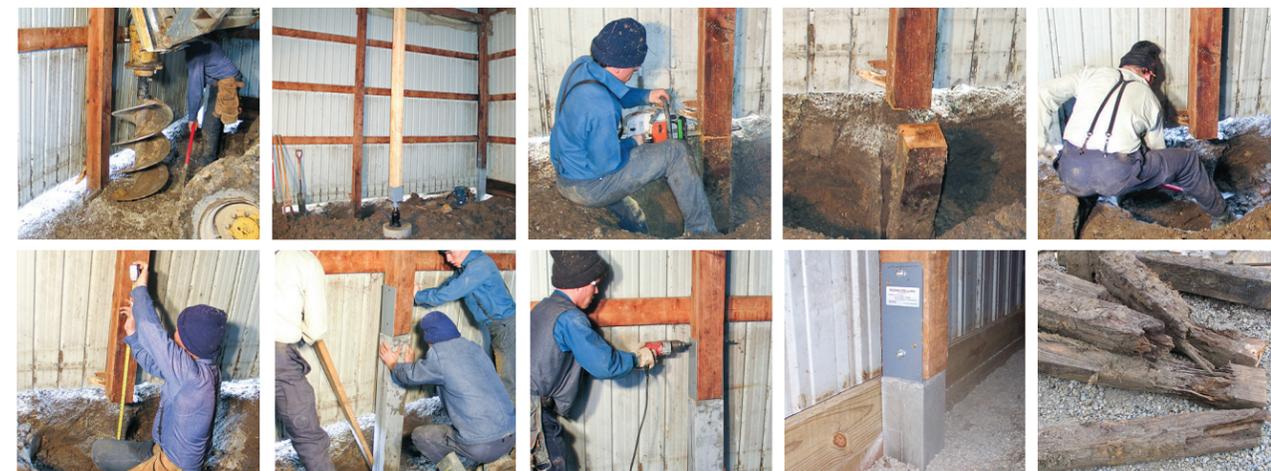
Remove post

1. Locate rotted post to be replaced.
2. Detach siding and remove existing skirt board.
3. Dig down next to face and sides of rotted post with auger.
4. Support truss with brace and hydraulic jack.
5. Cut rotted post off at ground level. No measuring necessary at this point.
6. Remove rotted portion of post.

Prepare for new post

1. Clean out post hole to provide a level, compacted base for the pre-cast concrete pad. Sakrete or ready mix concrete can also be used for post base.
2. Install pad and measure Perma-Column® for exact clearance needed. Note: Perma-Column® length may vary.
3. Mark existing post and cut to desired clearance for Perma-Column® installation.

Install Perma-Column®

1. Install and position Perma-Column®.
2. Install 1/4" x 3" wood screws. Drill and install 1/2" Grade 5 bolts. Length will vary based on model purchased.
3. Reattach siding and skirt board.

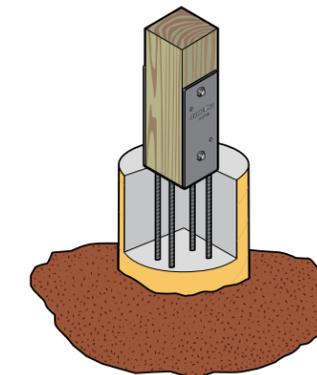
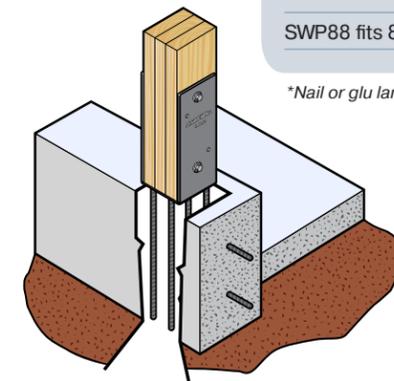
Available in 8 models

- SWP46 fits a 4" x 6" solid post
- SWP63 fits 3-Ply 6" column*
- SWP64 fits 4-Ply 6" column*
- SWP66 fits 6" x 6" solid post
- SWP83 fits 3-Ply 8" column*
- SWP84 fits 4-Ply 8" column*
- SWP85 fits 5-Ply 8" column* or 8" x 8" solid post
- SWP88 fits 8" x 8" architectural post

*Nail or glu lam column

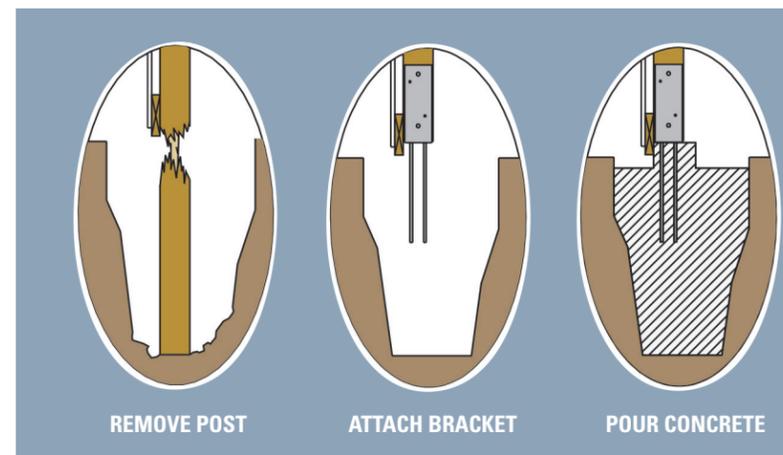
Remove post

1. Dig soil away from rotted post.
2. Inspect treated lower board for decay; it may need to be replaced.
3. Brace rotted post by fastening a support beam under truss and lifting with an adequate-sized jack.
4. Make sure brace and jack assembly are installed safely and securely.

Attach Sturdi-Wall® Plus bracket

1. Saw off rotted post approximately 3 inches below top of treated baseboard.
2. Remove rotted section of post.
3. Clean out all loose dirt from bottom of hole.
4. Tamp bottom of hole to ensure a solid base for poured concrete in Step 3.
5. Attach Sturdi-Wall® Plus bracket to bottom of post.
6. Install 1/4" x 3" wood screws. Drill and install 1/2" Grade 5 bolts. Length will vary based on model purchased.

Pour concrete

1. Use treated baseboard as outside form.
2. Install additional forming around base of Sturdi-Wall® Plus using plywood. Form should extend 2 to 3 inches beyond post on three sides and flush with baseboard.
3. Pour concrete to base of form and allow concrete to firm up slightly.
4. After previous pour has firmed, pour concrete to top of form (base of the bracket). Rod and tap concrete to ensure a completely consolidated fill under bracket. Do not over vibrate or aggregate will settle.
5. Remove brace and jack assembly after approximately 12 hours. Do not bump or fully load repaired post for 30 days.
